FIRST FLOOR
FIRE EQUIPMENT
PLAN

POOLE HOUSE:
SPORTS BLOCK

PH/S/FP/2R

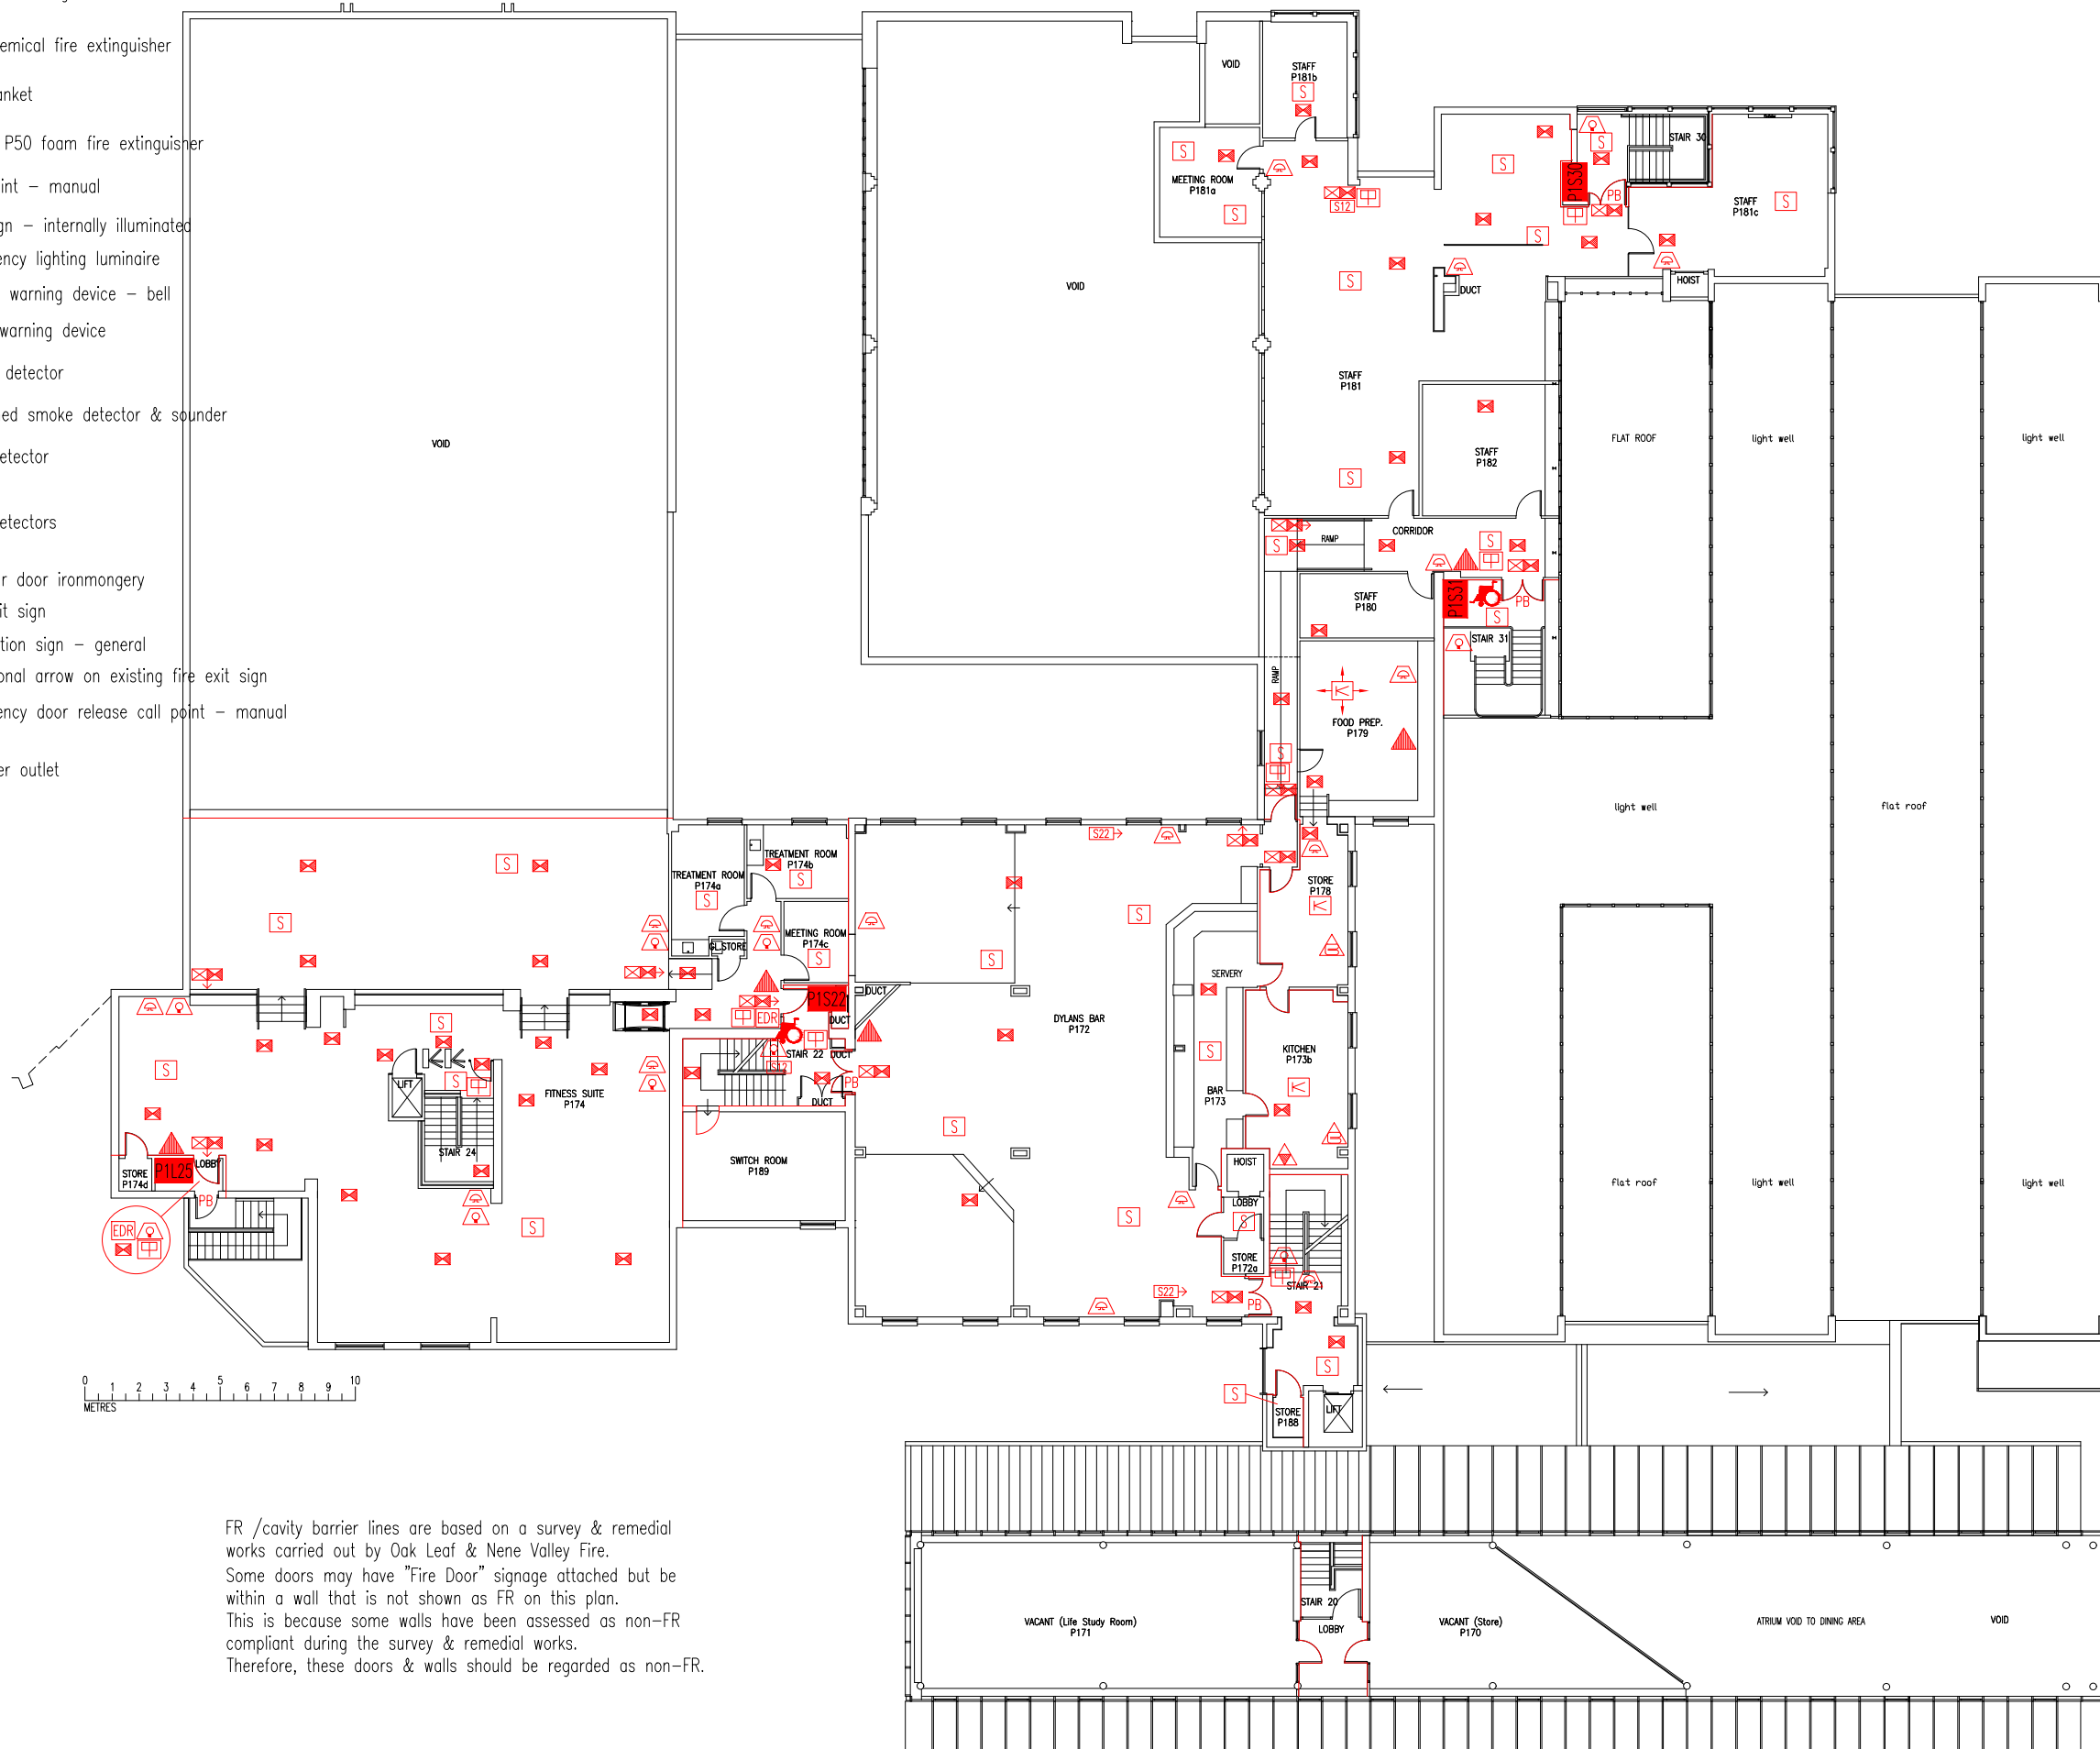
FR /cavity barrier lines are based on a survey & remedial works carried out by Oak Leaf & Nene Valley Fire. Some doors may have "Fire Door" signage attached but be within a wall that is not shown as FR on this plan. This is because some walls have been assessed as non-FR compliant during the survey & remedial works. Therefore, these doors & walls should be regarded as non-FR.
