## SECOND FLOOR FIRE PLAN

POOLE HOUSE:  
MAIN BLOCK

PH/M/FP/3V

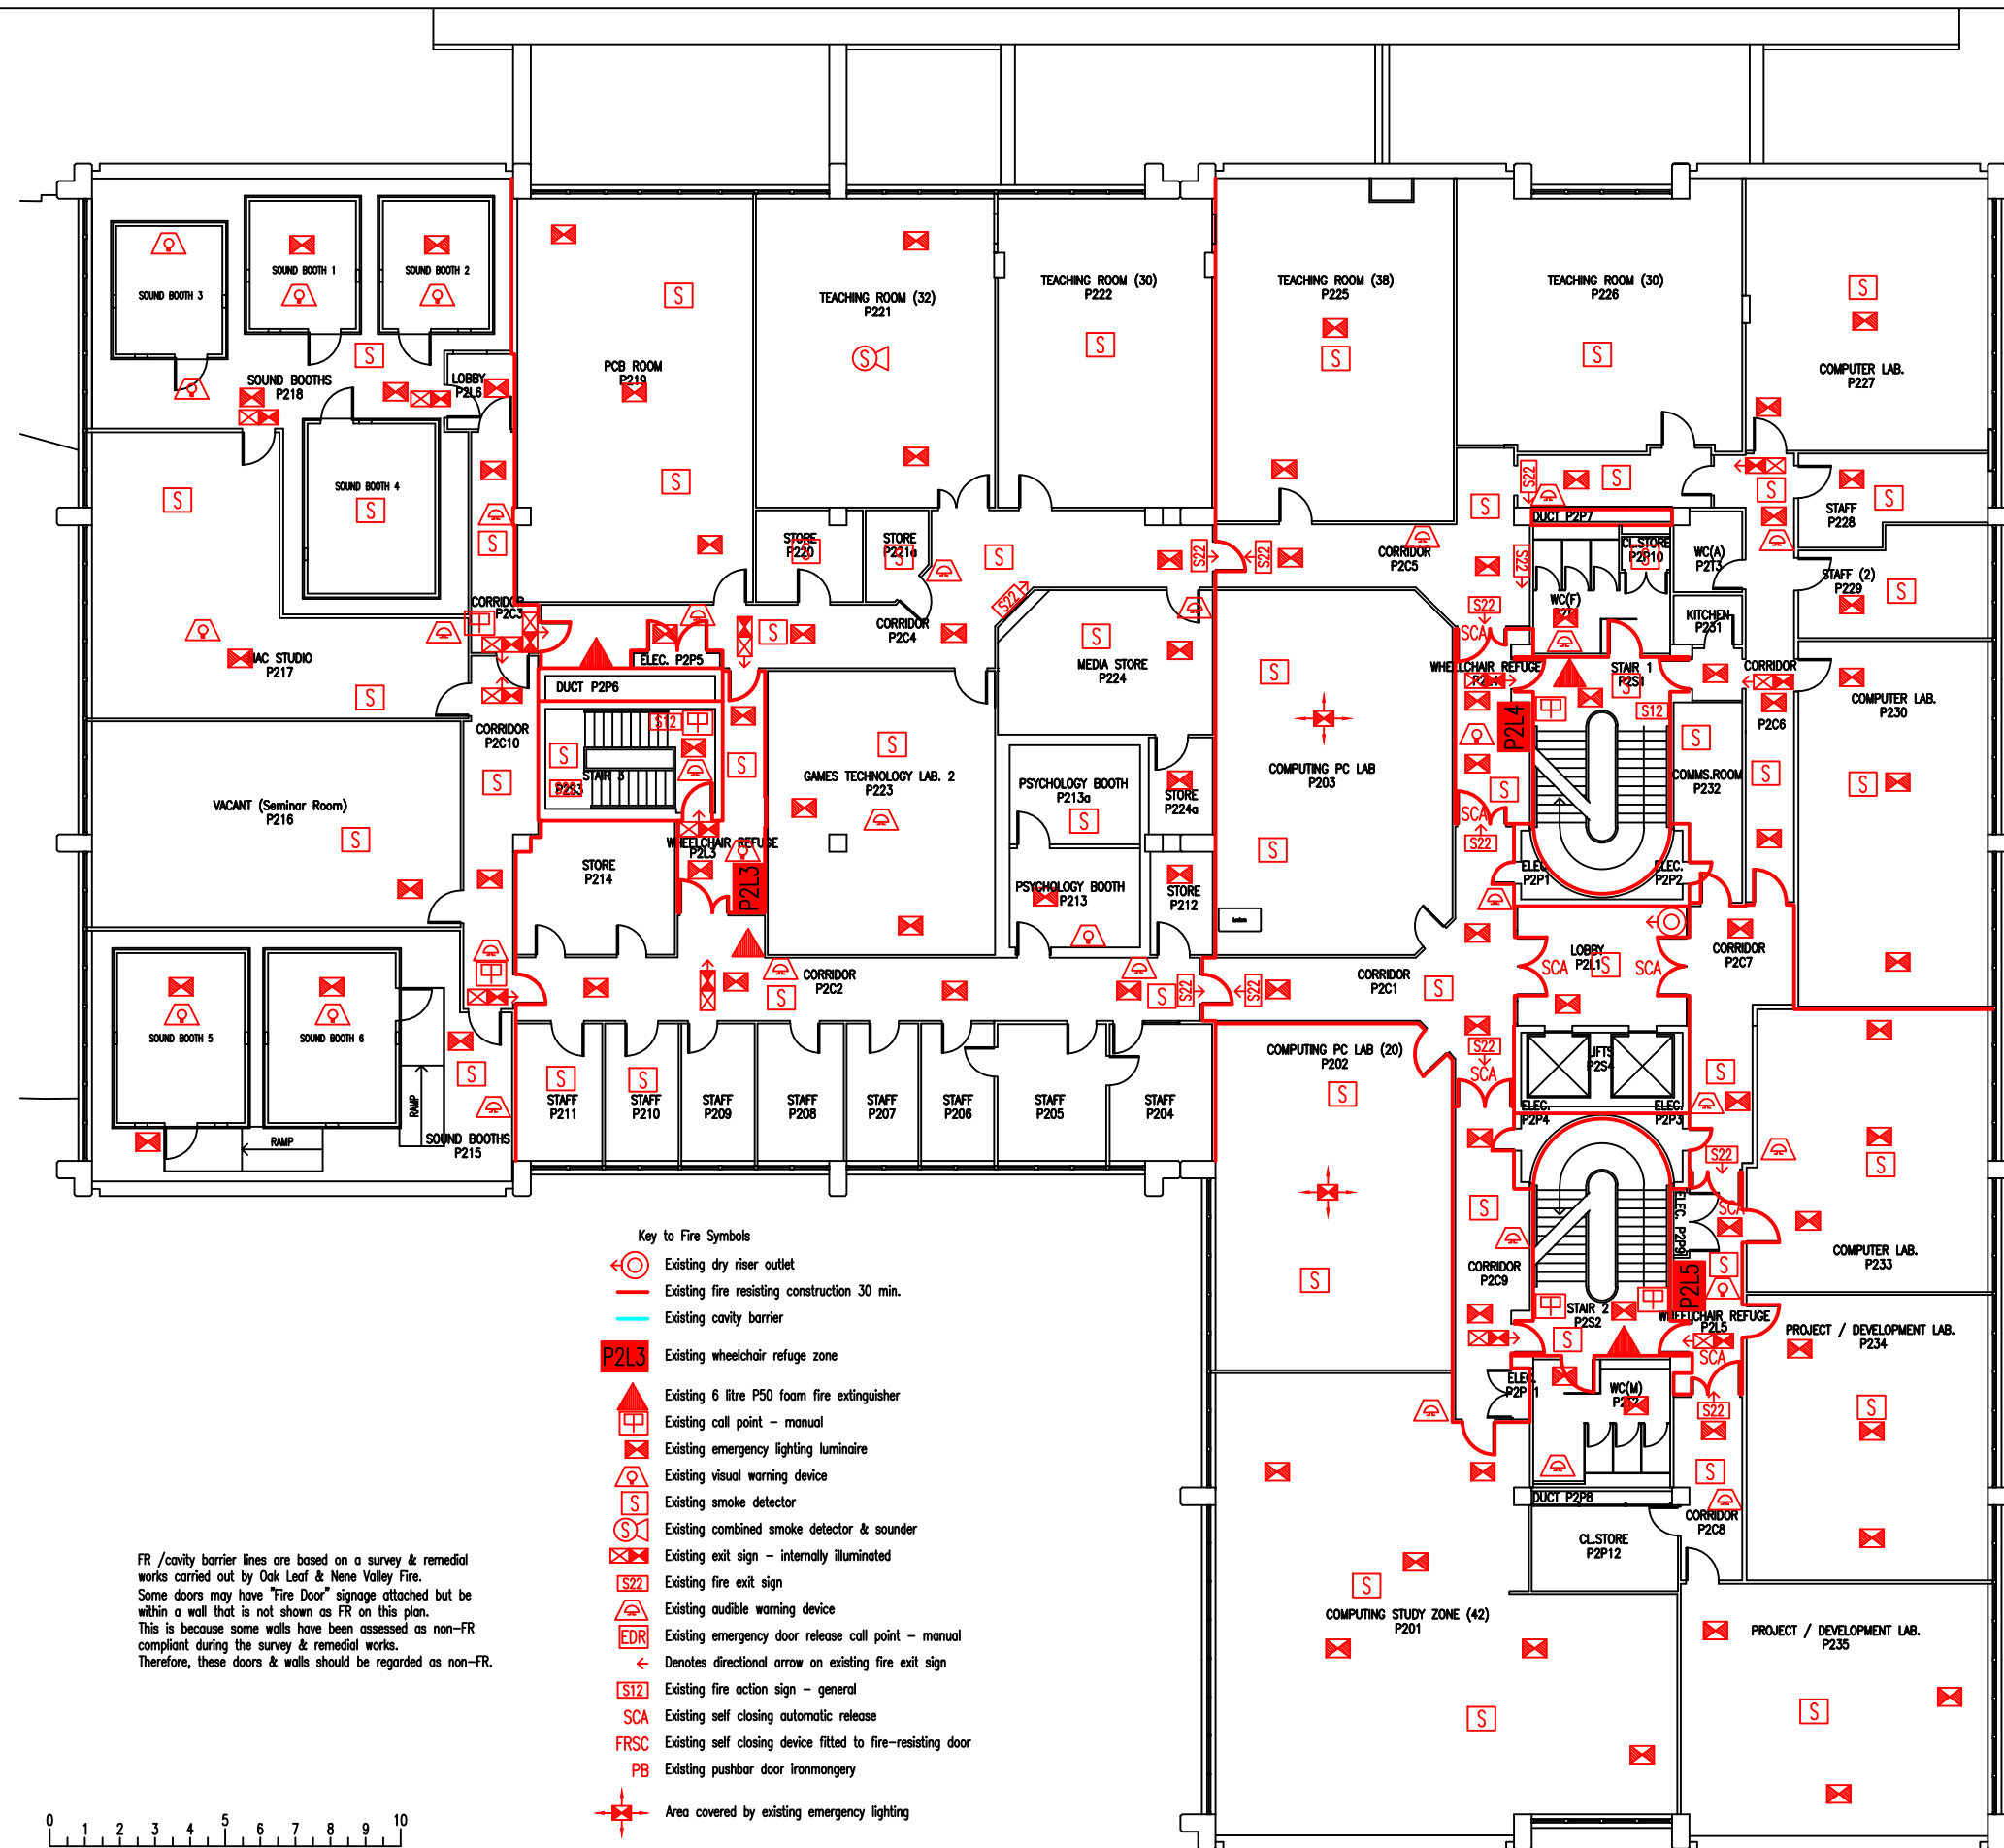
FR /cavity barrier lines are based on a survey & remedial works carried out by Oak Leaf & Nene Valley Fire. Some doors may have "Fire Door" signage attached but be within a wall that is not shown as FR on this plan. This is because some walls have been assessed as non-FR compliant during the survey & remedial works. Therefore, these doors & walls should be regarded as non-FR.
