THIRD FLOOR
FIRE PLAN

POOLE HOUSE:
MAIN BLOCK

PH/M/FP/4L

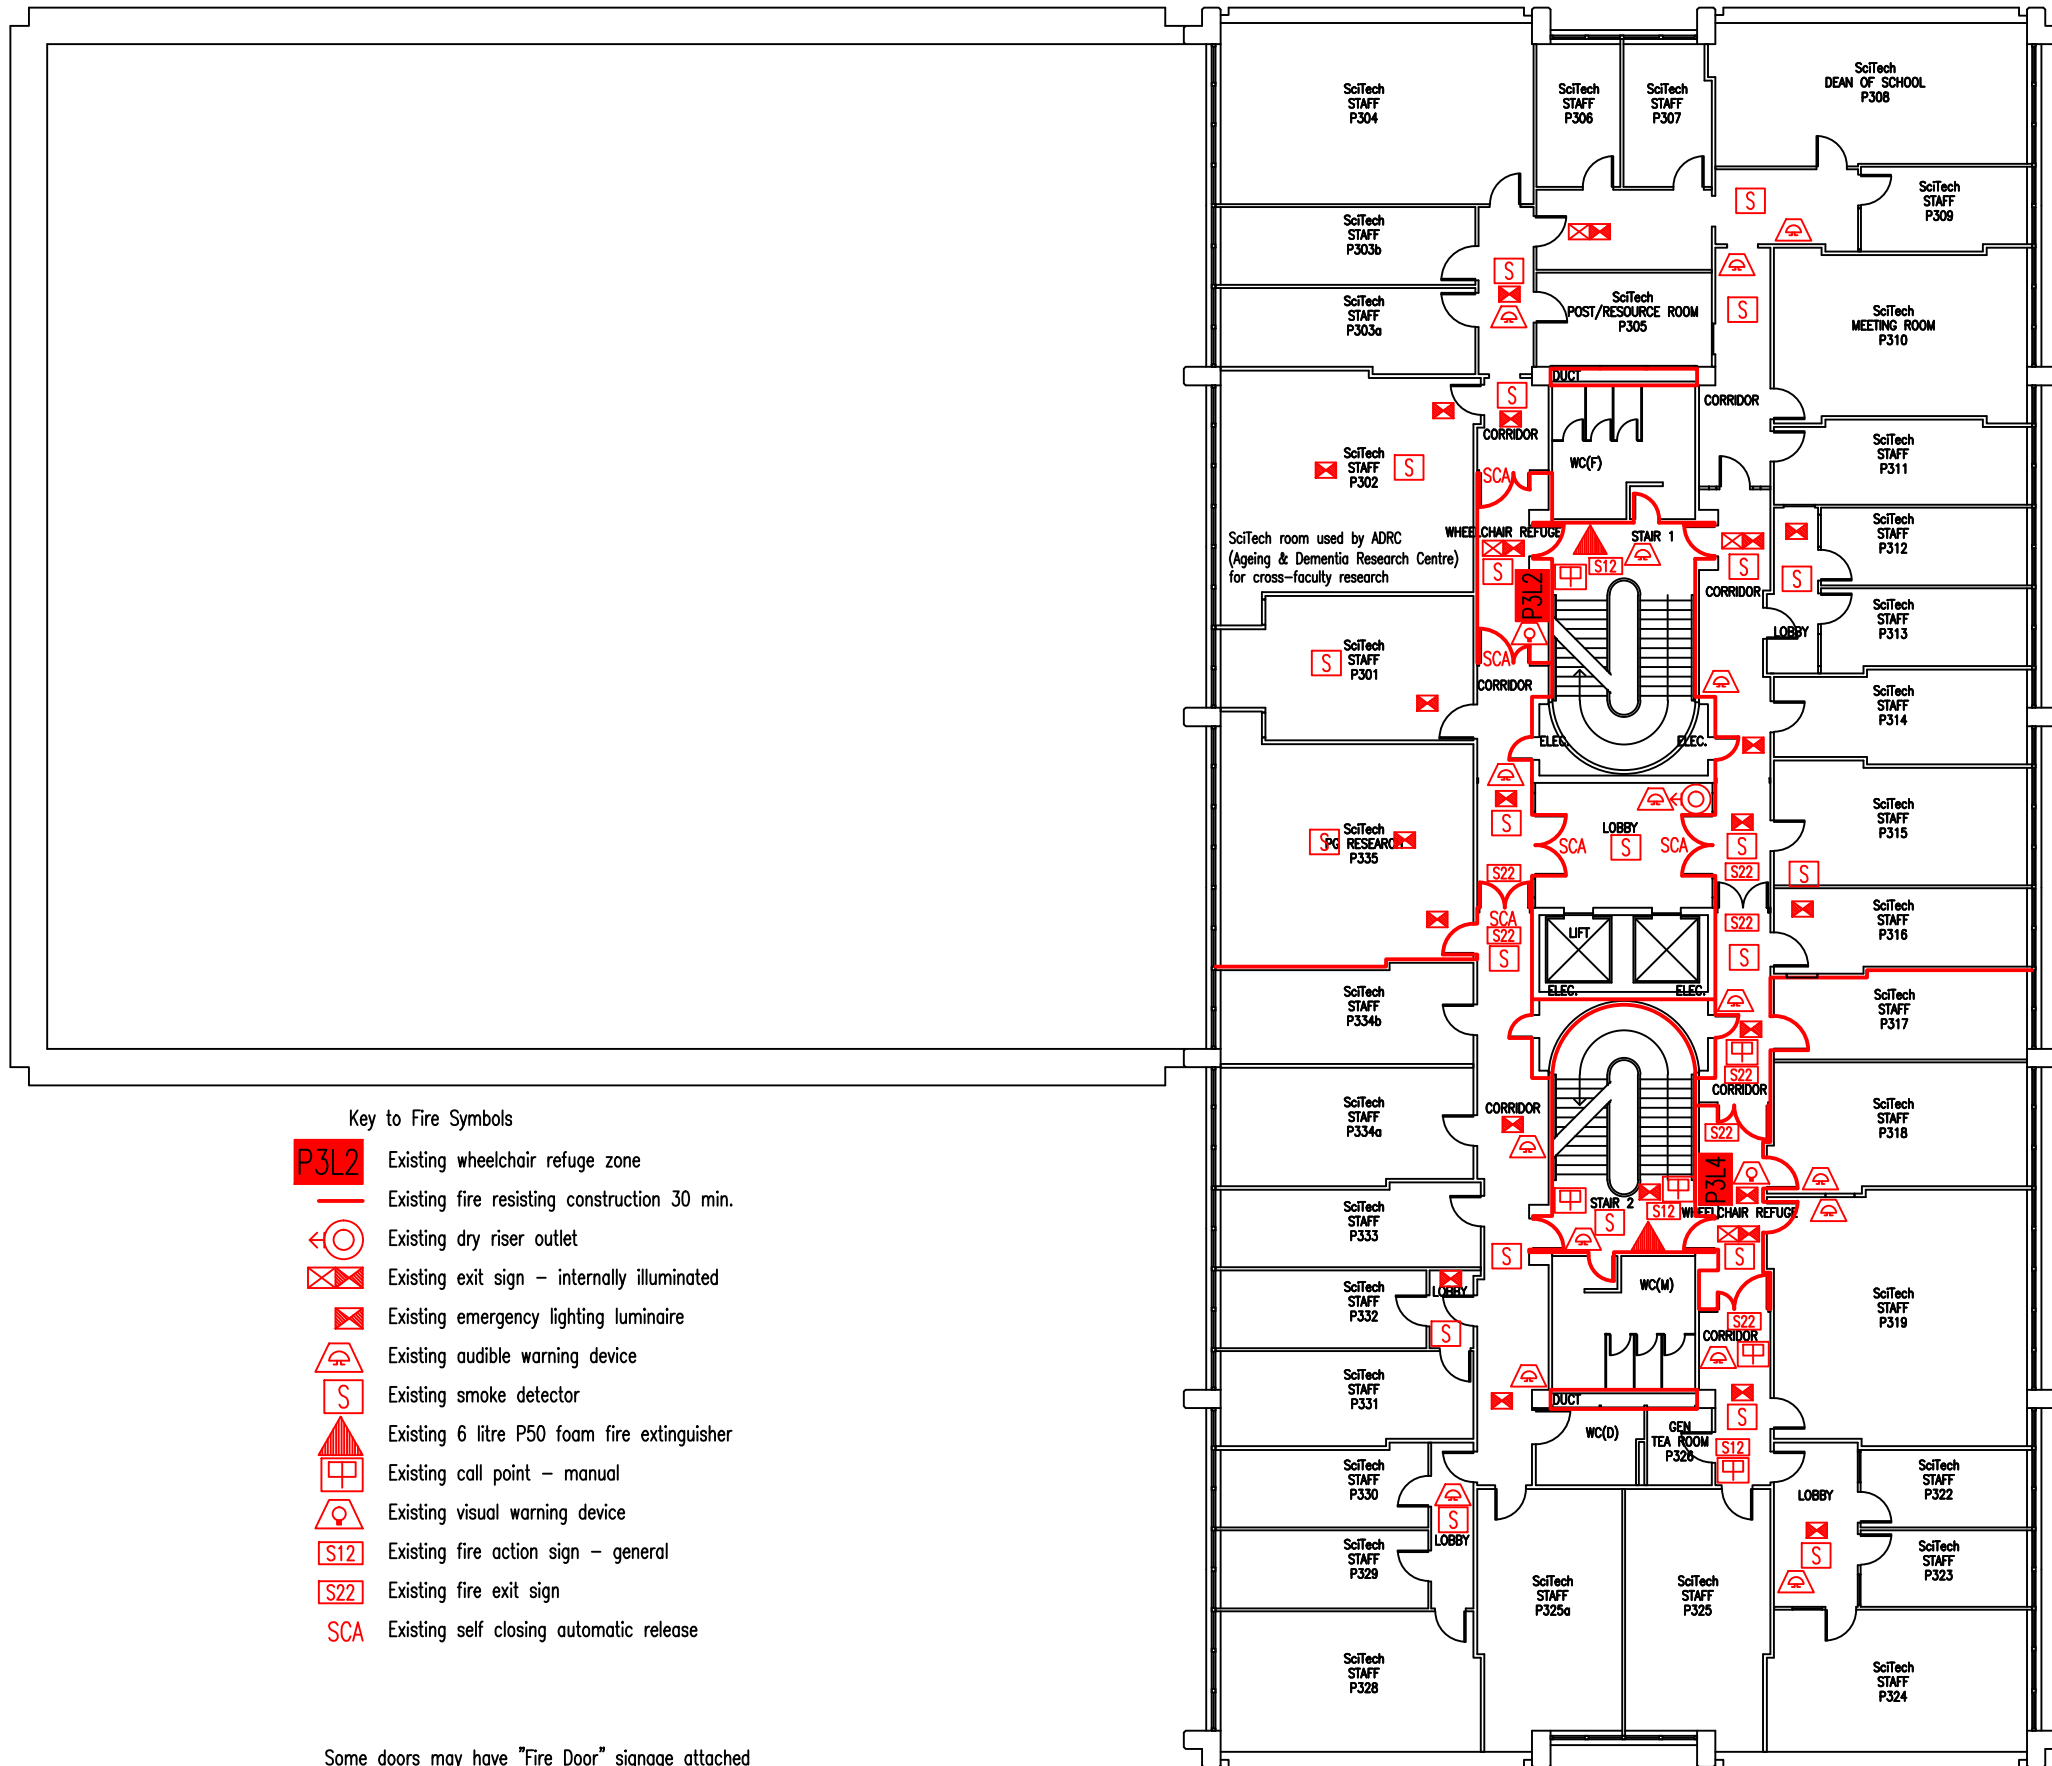
Some doors may have "Fire Door" signage attached but be within a wall that is not shown as FR on this plan. This is because some walls have been assessed as non-FR compliant during survey & remedial works carried out by external contractors. Therefore, these doors & walls should be regarded as non-FR.
